THIRD QUARTERLY TECHNICAL REPORT  
MONTANA LARGE APERTURE SEISMIC ARRAY

April 1970

(Prepared under Contract No. F19628-70-C-0010 by Philco-Ford Corporation,  
Communication and Technical Services Division,  
214 North 30th, Billings, Montana 59101.)

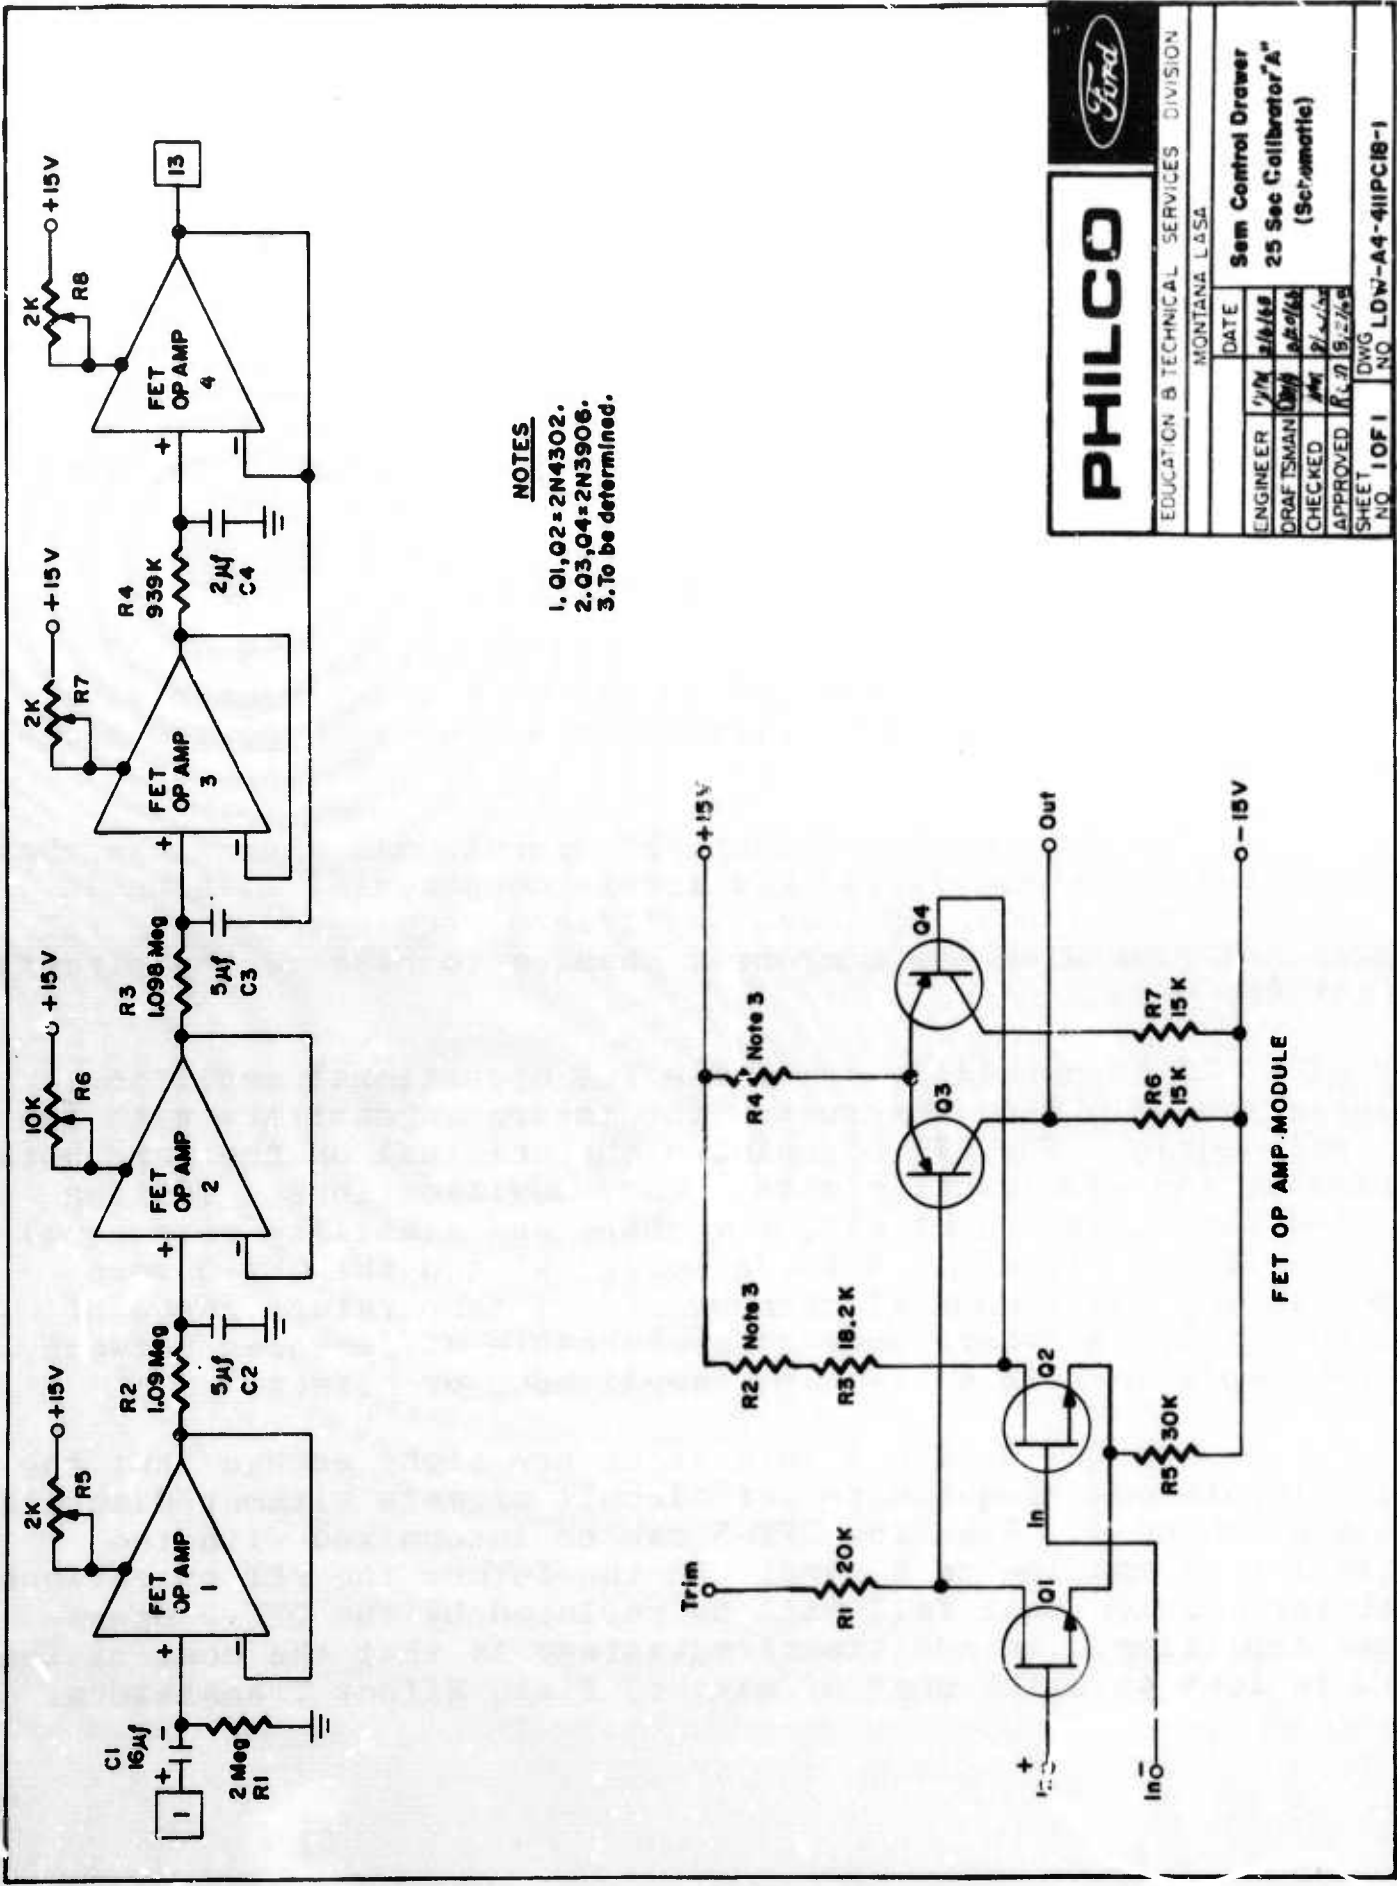
Figure 3.3 25-Second Calibrator A Schematic Diagram

The card contains four FET operational amplifiers that were originally produced, using discrete components, at Lincoln Laboratory. The repair of these amplifiers requires matched FET transistors plus discrete component changes to balance the circuit and set the gain.

A commercially available FET operational amplifier, Philbrick/Nexus QFT-5, was tested for interchangeability with the original module. The QFT-5 replaced the original on the card both physically and electrically without any modifications. Testing revealed that gain, dc offset, waveshape and stability were equal to the original circuit. Both the original and the QFT-5 were tested in the environmental chamber over a temperature range of +6°C to +56°C, and there were no measureable differences between the two amplifiers in wave-shape, amplitude, or offset.

The QFT-5 offset tolerances are tight enough that the card trimpots are adequate to set circuit offsets without discrete component changes. Also the QFT-5 can be intermixed with the original type modules on a card. In the future the FET operational amplifier modules that fail will be replaced by the QFT-5 operational amplifier. An additional advantage is that the cost of the QFT-5 is less than the cost of matched Field Effect Transistors.

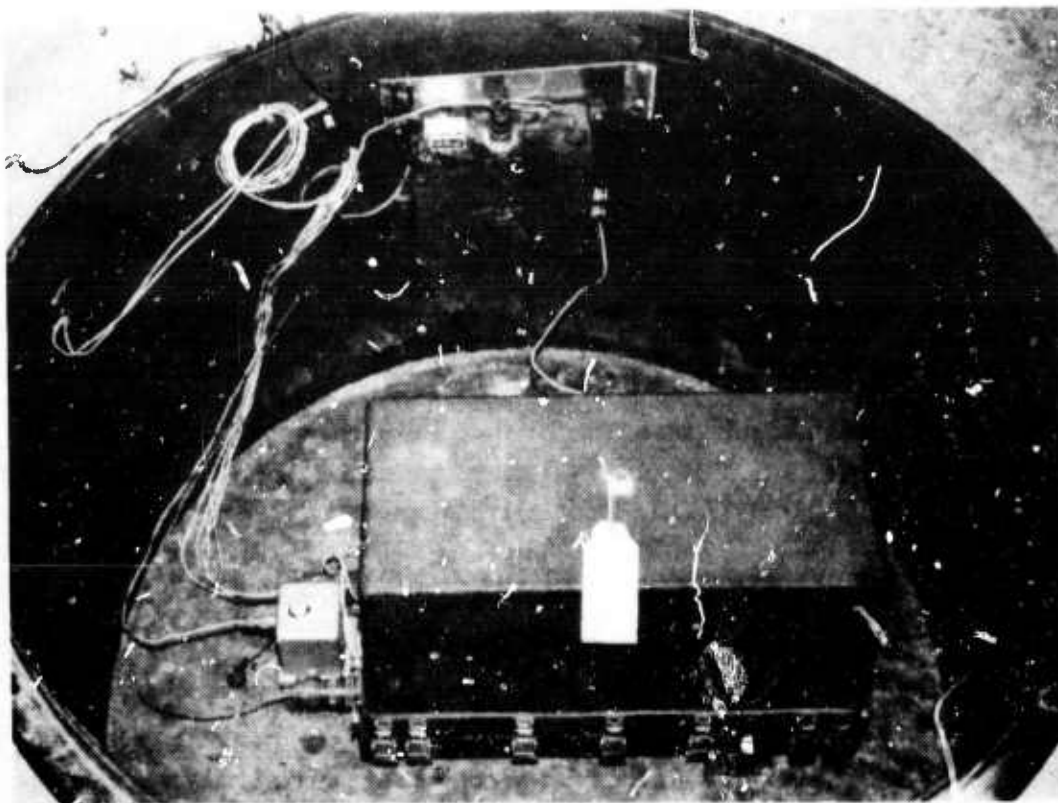
Figure 3.4 Vertical LP Seismometer Installation  
After Modification

The LP vault has inherently a high relative humidity of approximately 98%. The original installation of the vault included an unsealed junction box from which distribution of connecting cables was made to the three individual tanks and associated damping junction assemblies. As temperature changed within the vault, condensation took place and numerous troubles resulted from leakage between wires and ground, and crosstalk between wires. Approximately a year ago an attempt was made to seal the junction box to alleviate the problem, but proved unsuccessful. Leakage still occurred in the cabling and in the junction box. Since July 1969, 36 failures in the LP systems occurred due to this moisture problem.

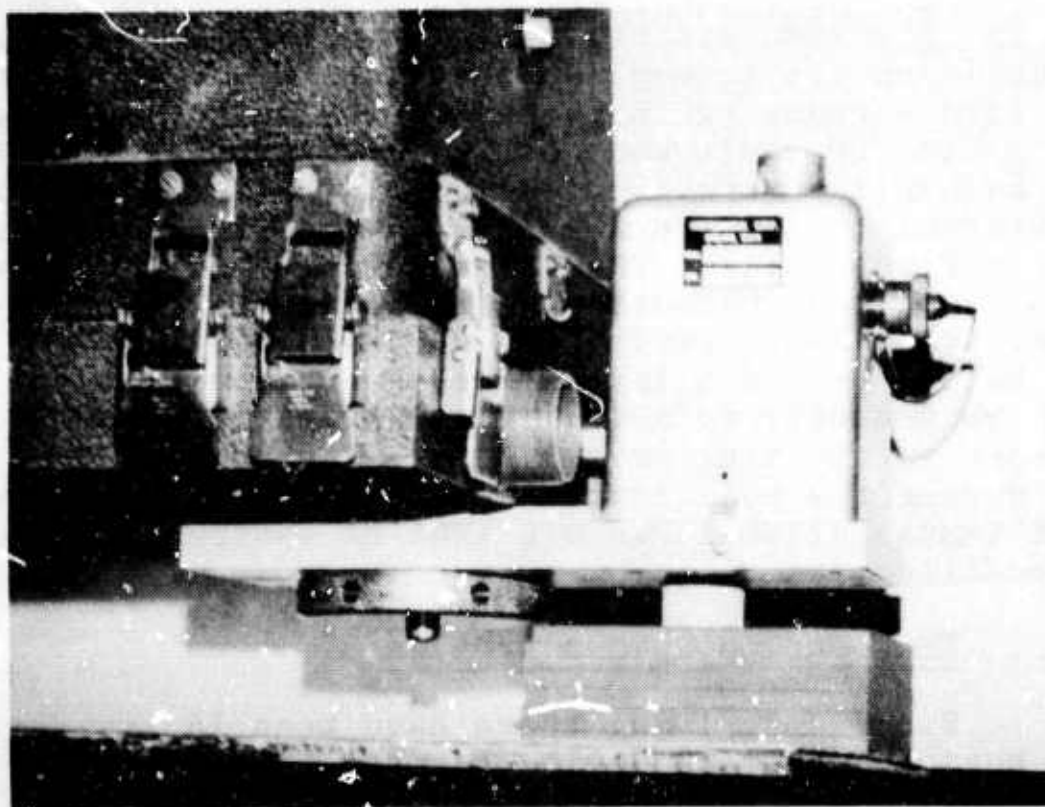
Figure 3.5 Modified Free-Period Remote Adjusting  
Device Mounting

Since July 1969, there have been 15 incidents where the free-period adjusting device reached the end of its travel while correcting the free period remotely from the LDC. The only solution to this problem in the past has been to open the tank and manually reset the free period. This is quite undesirable

as it means disturbing the instrument which may require several days to reach stable noise level again.

A one-month evaluation period was allocated for the first site during which noise levels were recorded prior to and after the modification in reference to other sites. The reinforcing of the mounting plate was a result of this evaluation. An increase in noise level of the vertical instrument in the range of 40 to 60-second periods was noted prior to the reinforcing of the mounting plate. While no evidence of noise was seen on the horizontal instrument, the same mounting technique was employed on them as a preventive measure. Observations of this site have shown no increase in noise level since the final configuration was installed.

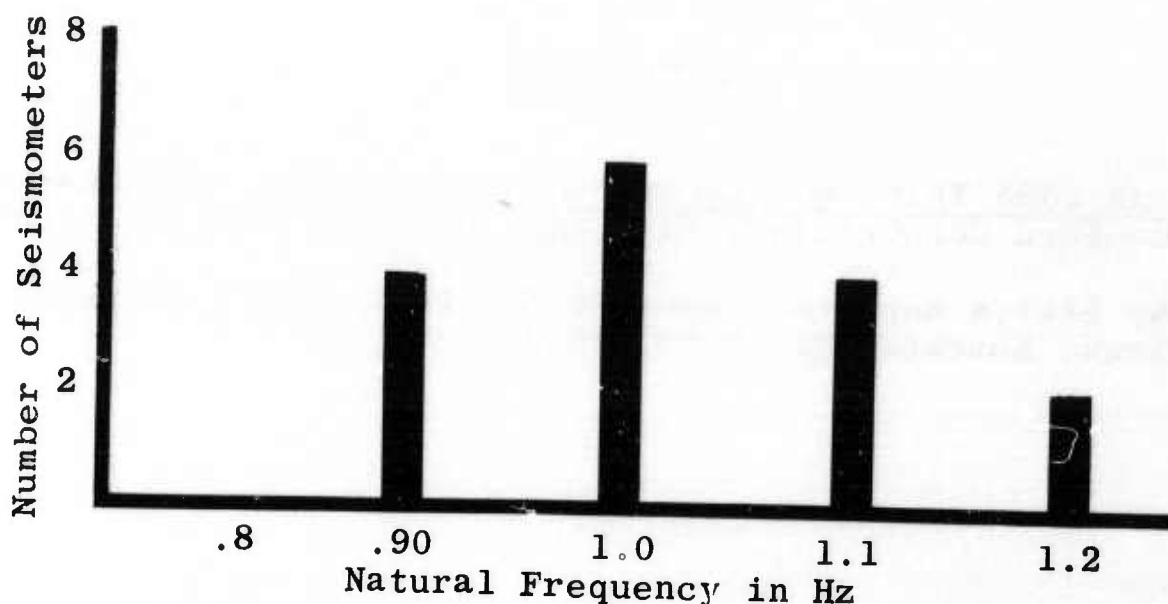
Figure 3.6 Distribution of SP Seismometer  
Natural Frequencies at Subarray C2

Seismometer natural frequency was measured using the Lissajous method. The distribution of natural frequencies at subarray C2 is plotted in Figure 3.6. A comparison of the results with original installation records indicates that seismometer natural frequencies have decreased an average of .07 Hz. This was substantiated by the fact that damping resistances had to be lowered in all cases where the damping was out of tolerance (overshoot ratio of 15:1 - 22:1). The exact cause of the decrease is unknown but it is suspected to be spring fatigue.
